The catalogue of earthen mortar walls in Cremona in order to evaluate their mechanical behaviour: the complexity and logic behind a construction technique

GRIMOLDI, ALBERTO¹; LANDI, ANGELO GIUSEPPE²

Keywords: *earthen mortars, Cremona, vaults*

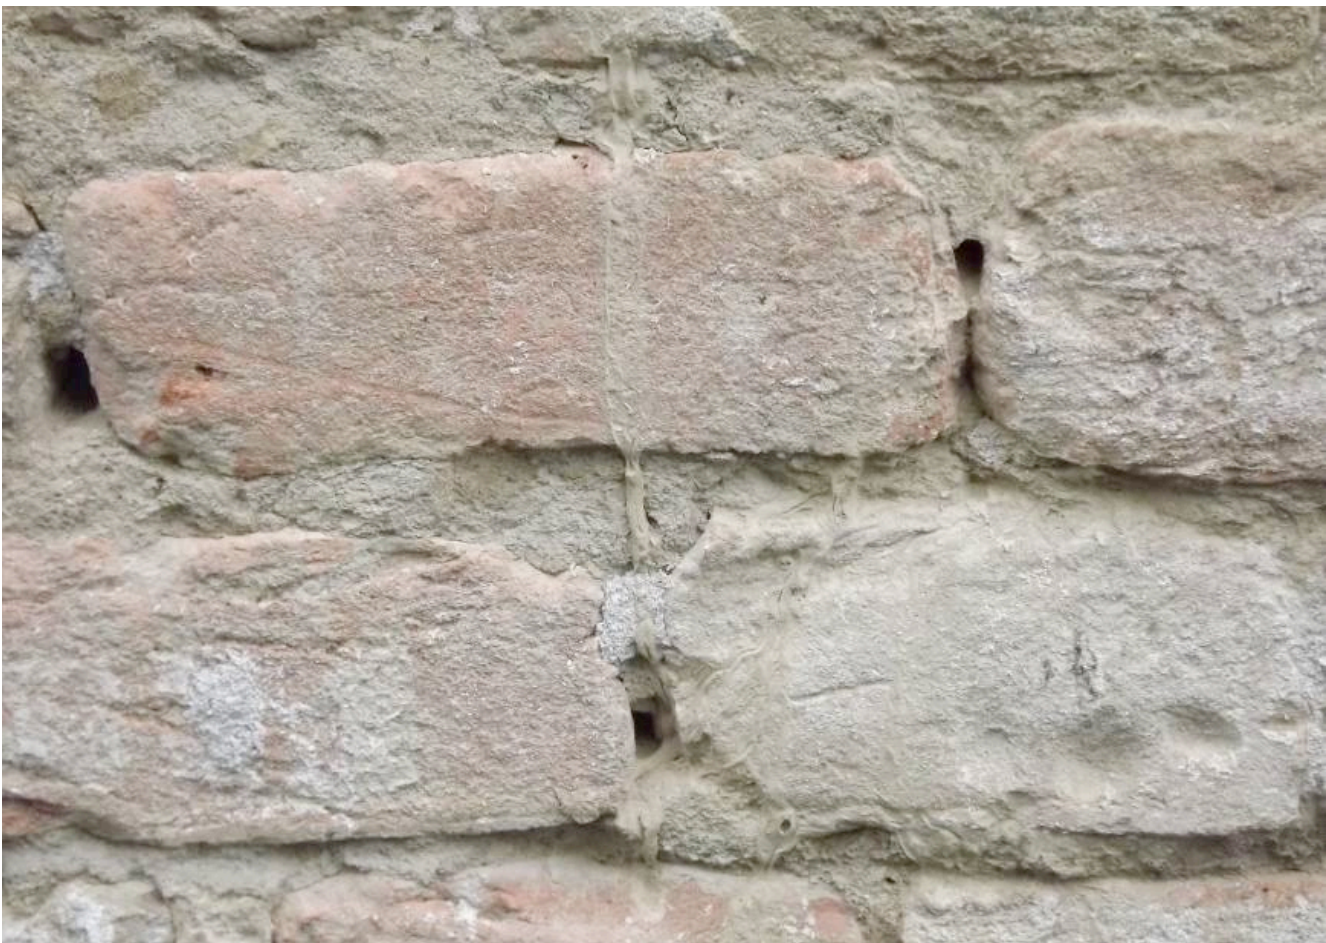
Figure 1. Detail of an earthen mortar masonry and the dripping of the earthen mortar, palazzo Magio Grasselli.

The use of earthen mortar for chimneys or discontinuities in the walls such as openings, windows or building joints has resulted, in many cases, in the appearance of clay dripping along the masonry. Diagnostic tests performed on masonry – both protected with plaster and bare – show substantial differences in the tension value at collapse, respectively 1.97 and 1.10 MPa (Figure 3; Table 1), and elasticity, which decreases rapidly with the increase of pressure applied. In both tests the jack plate penetrates no more than half of the thickness of the wall sections, and the values should be reconsidered taking into consideration the entire thickness. The values obtained would be far closer if you were to consider the entire depth of the wall; the shallow joints which (now empty due to the deterioration of the masonry) also contribute to the difference.

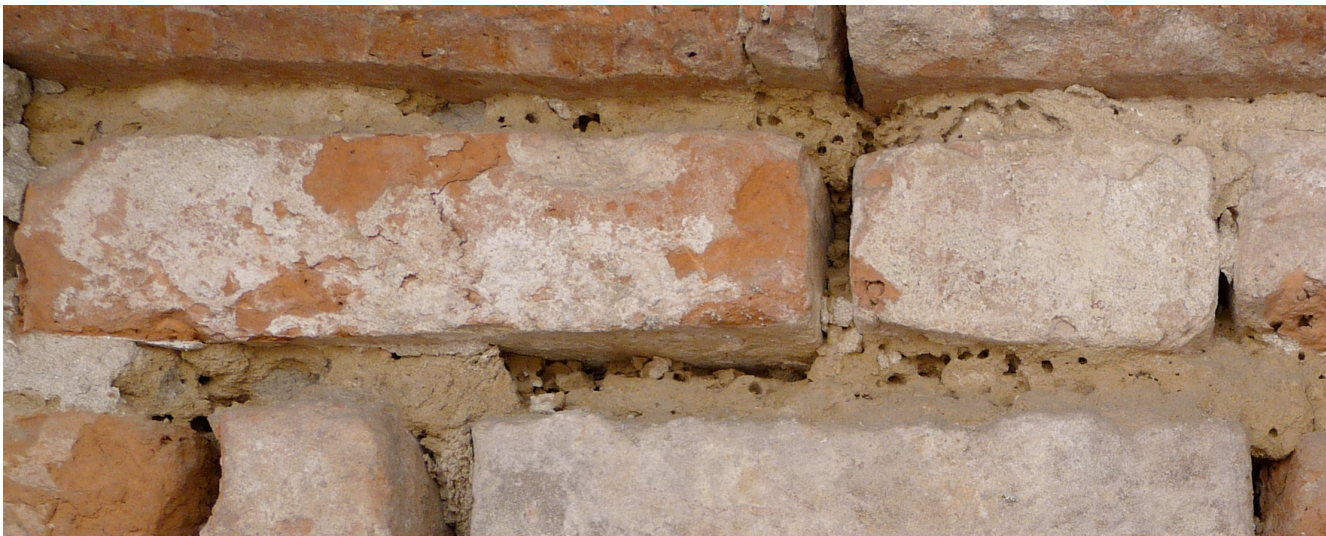
Figure 2. Decay of earthen mortars in palazzo Magio Grasselli

An interesting series of earthen mortars and their related forms of deterioration is visible in palazzo Magio Grasselli [17], whose Seventeenth-century restructuring assembled into a single building a number of pre-existing constructions, of which there are still traces in the walls: the deterioration of the plaster of the main façade has left visible the different textures of the walls that made up the pre-existing buildings, all built with clay mortar. A Fifteenth-century house incorporated in the palace, the so-called “Casa Lotica” on the western side of the façade, presents very regular horizontal brick courses, with vertical staggered joints and intact bricks. The clay mortar is protected from atmospheric agents and moisture condensation thanks to a lime based joint covering with traces of “fregatura” – a protective finish of the exposed brick – and a red tint, used to make the hue of the facing brick uniform. Only in the Seventeenth century, was this surface covered with a clay and lime plaster of which only fragments remain.

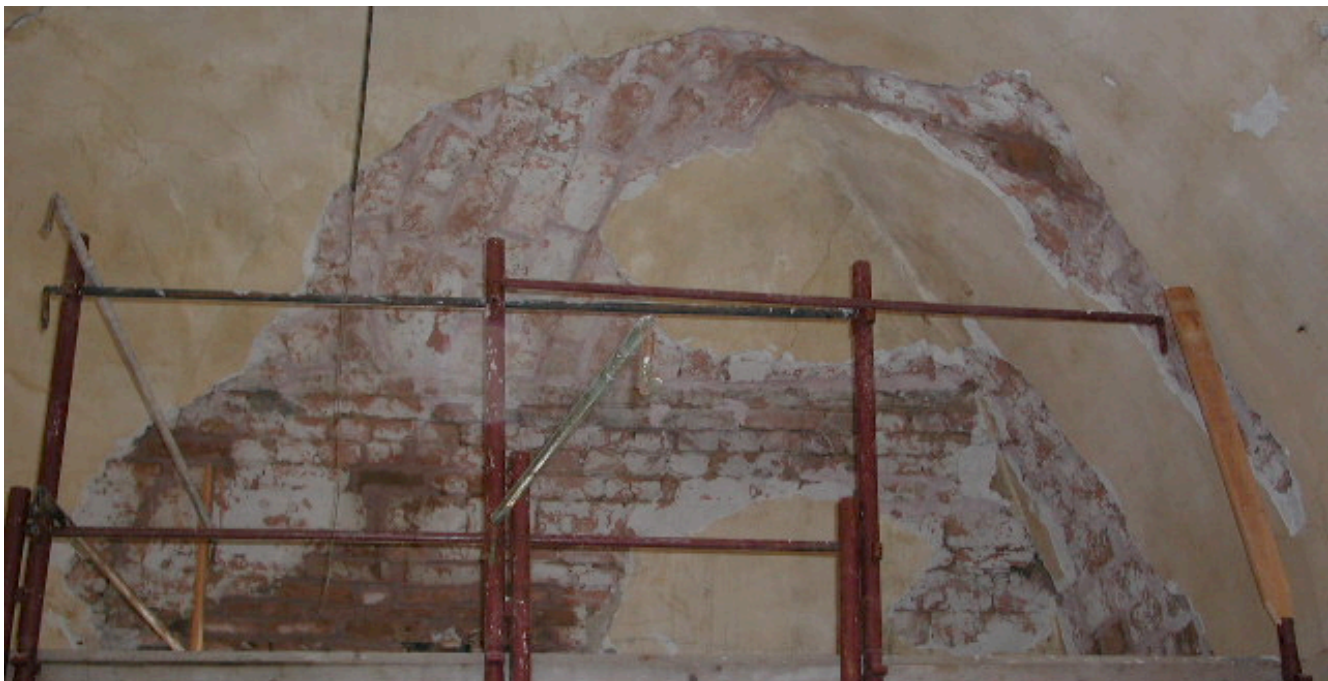
Figure 6. Detail of a vault in palazzo Pallavicino Ariguzzi.

part of the original construction; however in civil buildings they are, more often, later additions to existing walls. For floors above ground, they are almost exclusively constructed with lime mortar. Barrel, groined cloister or umbrella vaults of the Fifteenth century, with sequences of corbels and small arches, were followed in the Sixteenth century by cloister vaults with larger groins and corbels similar size of the arches, realized in a herringbone pattern. Both springers and corbels are strongly inclined to reduce the drift transmitted by the bricks that are set to not more than one head in the masonry, while the arch is often simply placed against the wall. When it is necessary a continuous springer, the procedure used for the frames of the gutter is often replicated: this is achieved by progressively increasing the jutting out of rows of bricks bonded by earthen mortars. In both cases, on the springers of the vaults, bricks are laid *in folio* so as to reduce the weight. A combination of thicker and steeply inclined springers and an almost flat surface can be seen in the vaults of two rooms on the first floor of the palazzo Ariguzzi Pallavicino, in a wing added around 1671 (Figure 6). The springers of the vaults are built with a single brick course, laid horizontally, in continuity with the vertical walls. These continue for almost half of the height of the vault and allow the formation of the sweep.
